September 16, 2013

04-0120F4

SFOBB SKYWAY BIKEPATH

Skyway Bikepath Corrosion Investigation and Evaluation

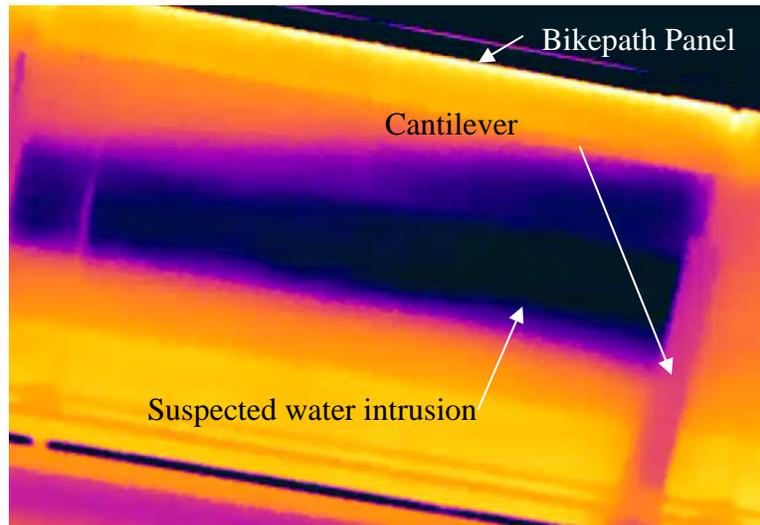
Figure 1: Typical infrared (IR) photo showing intrusion of water.

During the demonstration, the FLIR camera revealed that several panels appeared to have standing water on the Skyway portion of the bridge (**Appendix 1**). The shape and location of the low temperature areas in a typical image (**Figure 1**) proved to be an effective method to identify the problematic panels. No panels showed signs of standing water on the SAS bike path.

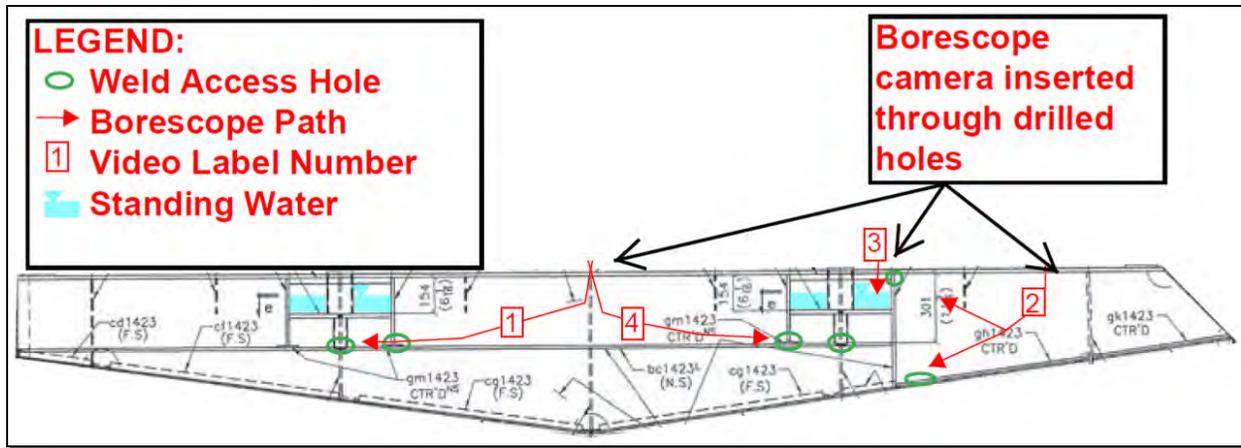
METS also conducted a borescope investigation attempting to identify a pathway for water. The suspected water intrusion source was the anchor rod screw caps; however shop drawings show this to be not connected to main, air-tight compartments. The contract plans and shop drawings also confirm that there is no connection between compartments of the cantilever beam to the compartments of the bikepath panels. A General Electric XL Go borescope was inserted through several different holes drilled into the top surface of the bike path. An identification map showing the borescope's paths of insertion is seen in **Figure 2**. This figure also shows where weld access holes were discovered (green circles) which would allow air and water to pass throughout the compartments. Photographs of these weld access holes, taken with the borescope are seen in **Figures 3 through 8**. The access holes that were discovered provide a path for water from around the anchor rod sleeves throughout the diaphragm ledge above the cantilever beam. However, no apparent path was found which would trace water from the anchor rod cap threads into the main compartment. The standing water marked as 'Video Label Number 3' in **Figure 2** was manually poured in by METS during investigations to determine if the water would leave the chamber around the sleeve. This chamber was found to be watertight and the water will need to be removed at a later date.

Figure 2. Borescope camera path identification map.

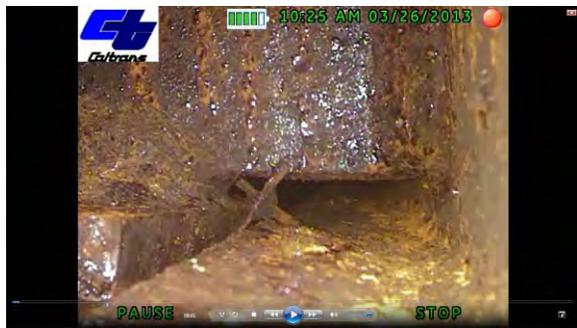
Figure 3. First weld access hole in camera path #1.

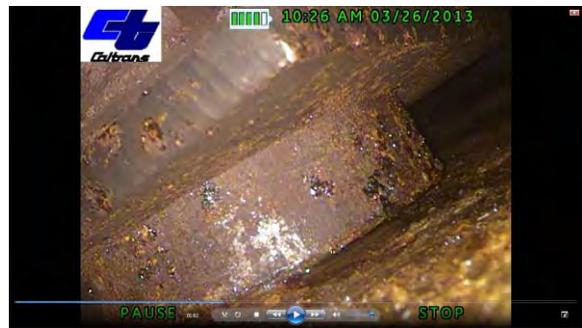
Figure 4. Gap between sleeve and soffit.

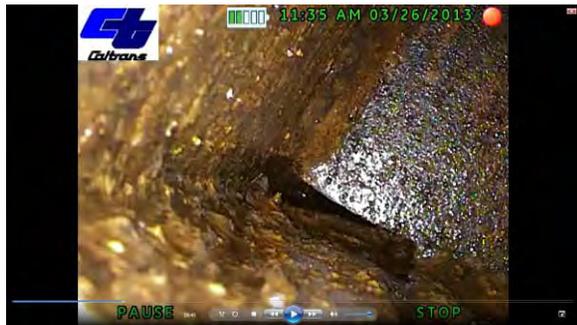
Figure 5. Weld access hole in camera path #4.

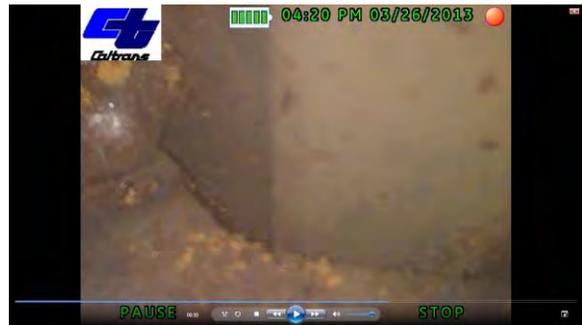
Figure 6. Weld access hole in camera path #3.

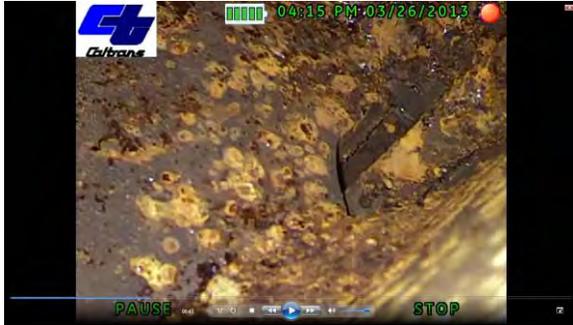
Figure 7. Top cope hole in camera path #2.

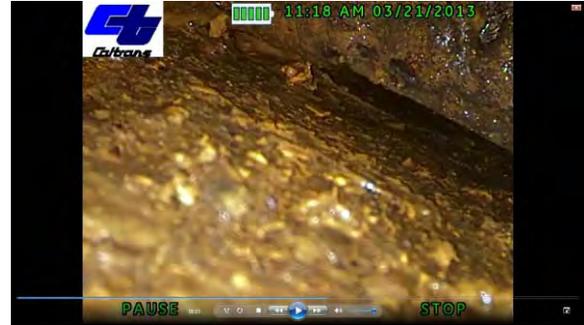
Figure 8. Weld access hole allowing water to enter into box sections which are intended to be air-tight.

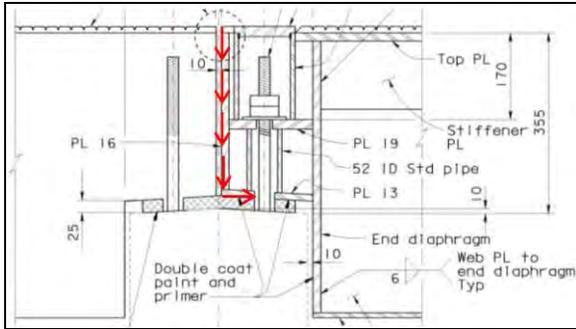
- 1) The cantilever beam bearing on the elastomeric pad (**Figure 9**).
- 2) The underside of the gap closure plate near the sleeve threads (**Figure 11**). The gap closure plates were found to be shimmed into place using ordinary washers as spacers. This would allow air to enter below this plate next to the anchor sleeve threads.
- 3) The threads of the anchor rod sleeve circular cap (**Figure 13**). Bubbles were seen during the investigation in 2 of the 4 panels tested.

Figure 9. Air source at elastomeric pad.

WJE included a recommendation in their report to evaluate the installation of a sealant system at the joint between box girders for selected panels with known infiltration. METS believes that this point of ingress can be more effectively sealed. For this reason, METS recommends that Design, Construction, and Maintenance consider evaluating the injection of a sealant material throughout the anchor rod sleeve. This would seal off point of air ingress from any gaps near the elastomeric bearing pads.

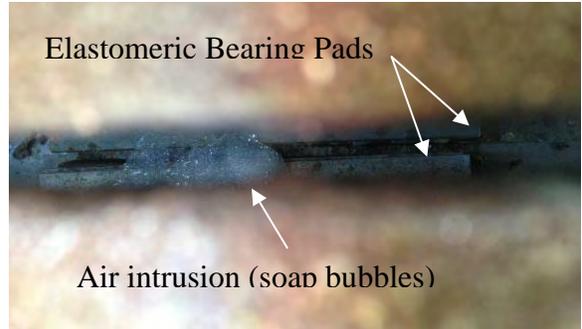
Figure 10. Air bubbles at bearing pads.

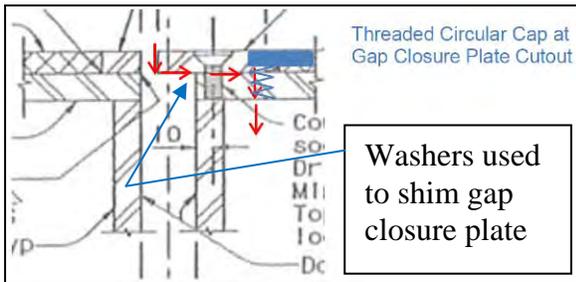
Figure 11. Air source at underside of gap closure plate near sleeve threads.

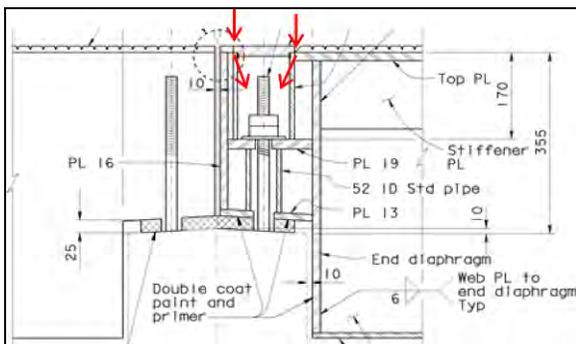
Figure 13. Air source at screw cap threads.

- 1.) Conduct biennial infrared camera surveys to detect any significant water ingress to box girders
- 2.) Dewater box girders known to hold water biennially and record extracted water volume. In addition, install valves at the lowest point of at least six box girders which are not known to contain water and include them as part of the dewatering program.
- 3.) Conduct a visual survey to evaluate the presence of damage or wear to the coating/overlay around the circular threaded caps in five years and biennially thereafter. If distress is observed, it should be addressed as soon as possible to minimize the ingress of water through the circular threaded caps.

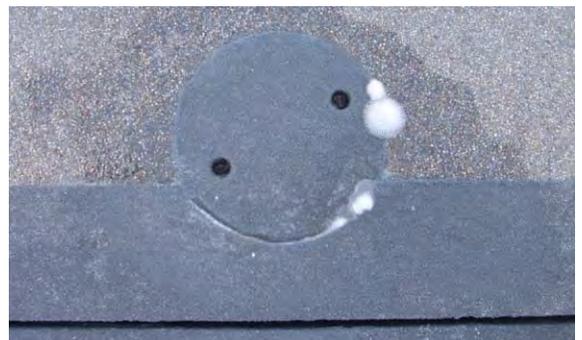
Figure 14. Bubbles from screw cap threads

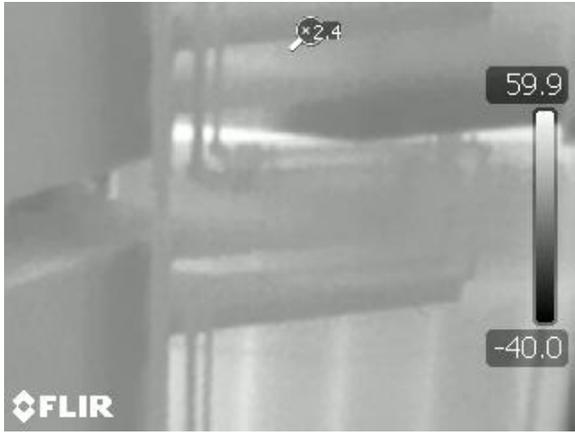
Figure 3. Water suspected in expansion joint panels

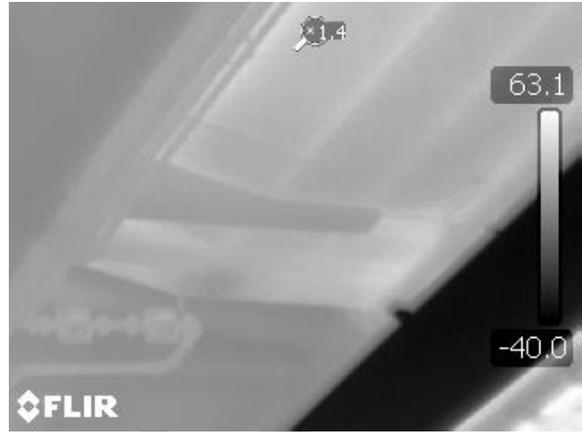
Figure 4. Water suspected in expansion joint nearest OTD

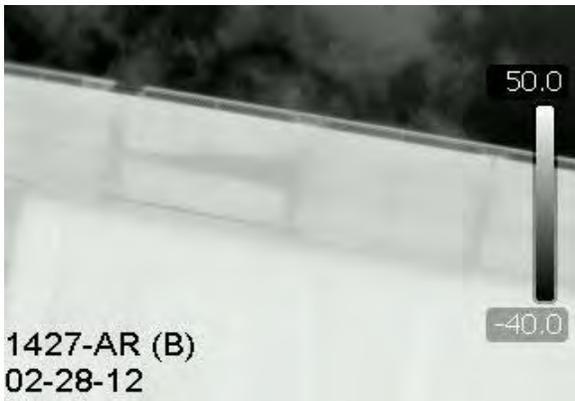
Figure 5. Typical panel with suspected water on 2-28-12 inspection
