September 16, 2013

04-0120F4

SFOBB SKYWAY BIKEPATH

Skyway Bikepath Corrosion Investigation and Evaluation

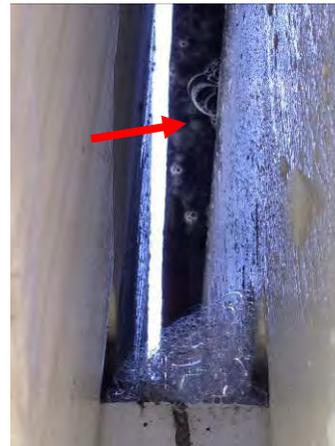
- 1) The cantilever beam bearing on the elastomeric pad (**Figure 9**).
- 2) The underside of the gap closure plate near the sleeve threads (**Figure 11**). The gap closure plates were found to be shimmed into place using ordinary washers as spacers. This would allow air to enter below this plate next to the anchor sleeve threads.
- 3) The threads of the anchor rod sleeve circular cap (**Figure 13**). Bubbles were seen during the investigation in 2 of the 4 panels tested.

The testing also confirmed that there is “communication” between all compartments within the panel. The sections which were designed to be air-tight after seal welding are able to exchange air and moisture with other compartments.

Figure 12. Bubbles at underside of gap closure plate.

WJE included a recommendation in their report to evaluate the installation of a sealant system at the joint between box girders for selected panels with known infiltration. METS believes that this point of ingress can be more effectively sealed. For this reason, METS recommends that Design, Construction, and Maintenance consider evaluating the injection of a sealant material throughout the anchor rod sleeve. This would seal off point of air ingress from any gaps near the elastomeric bearing pads.

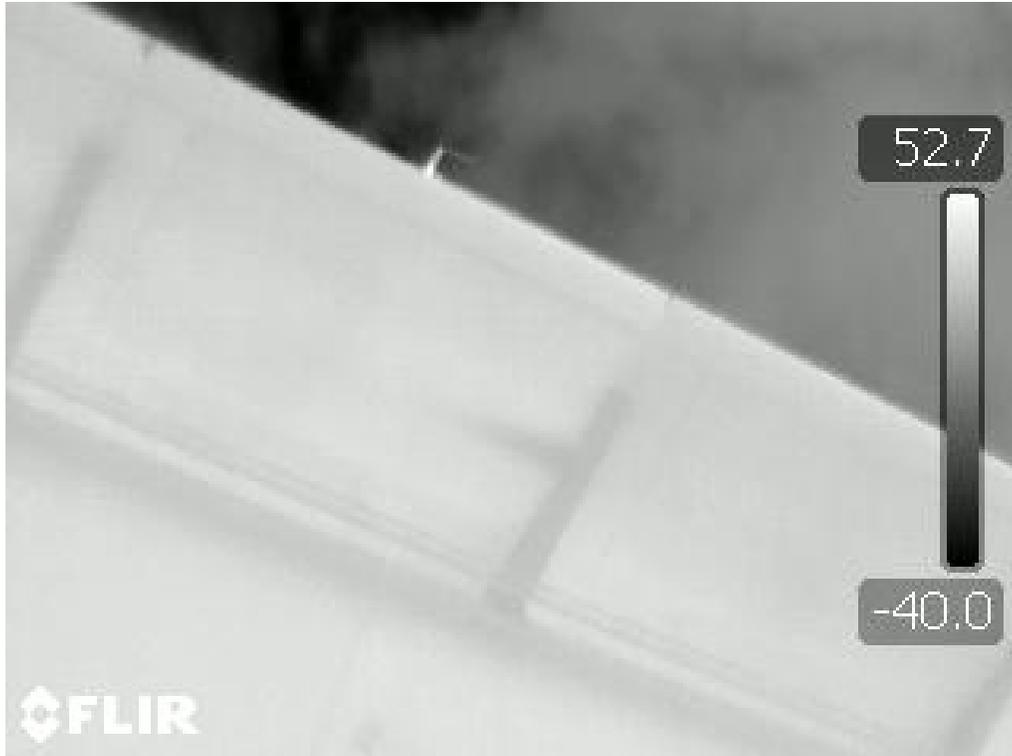
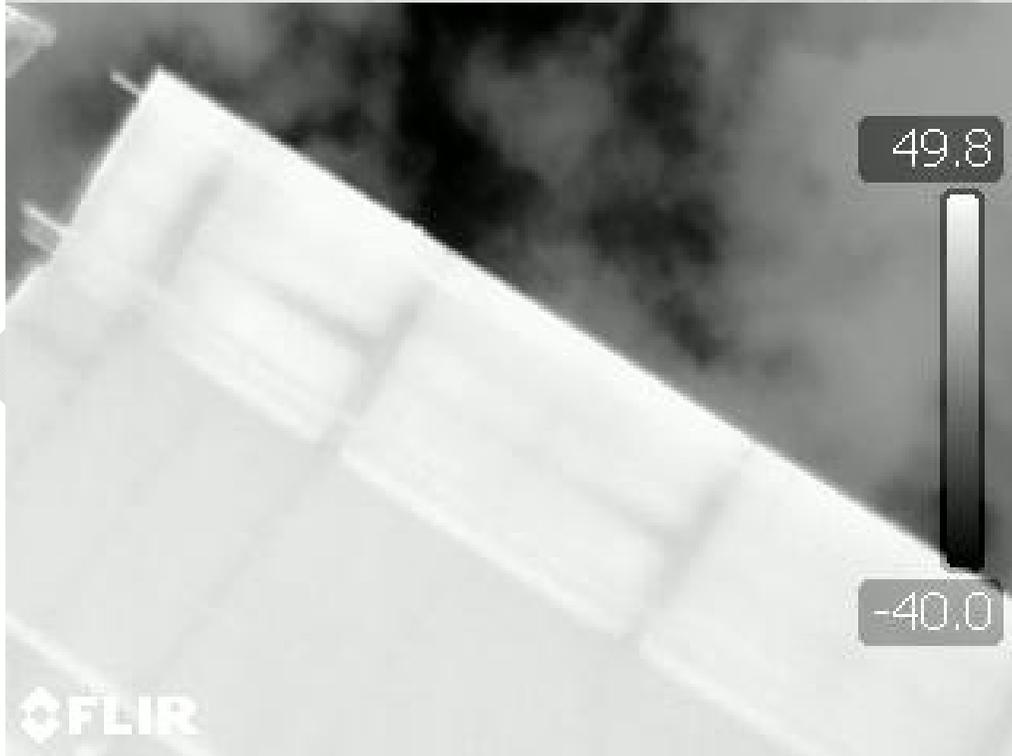
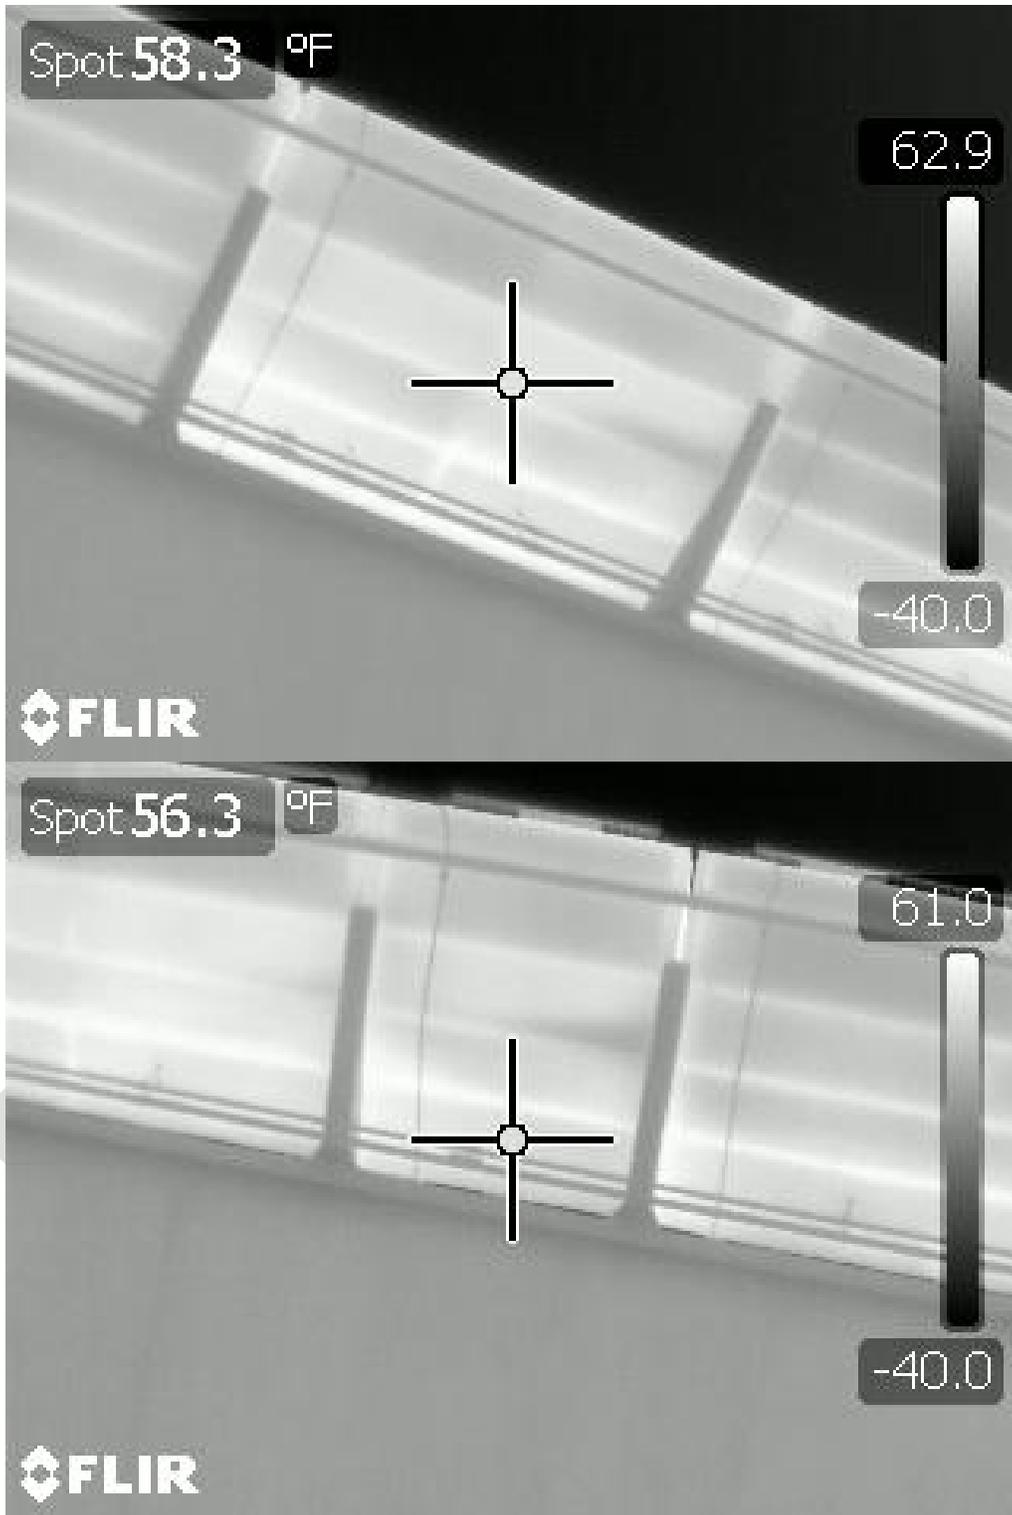
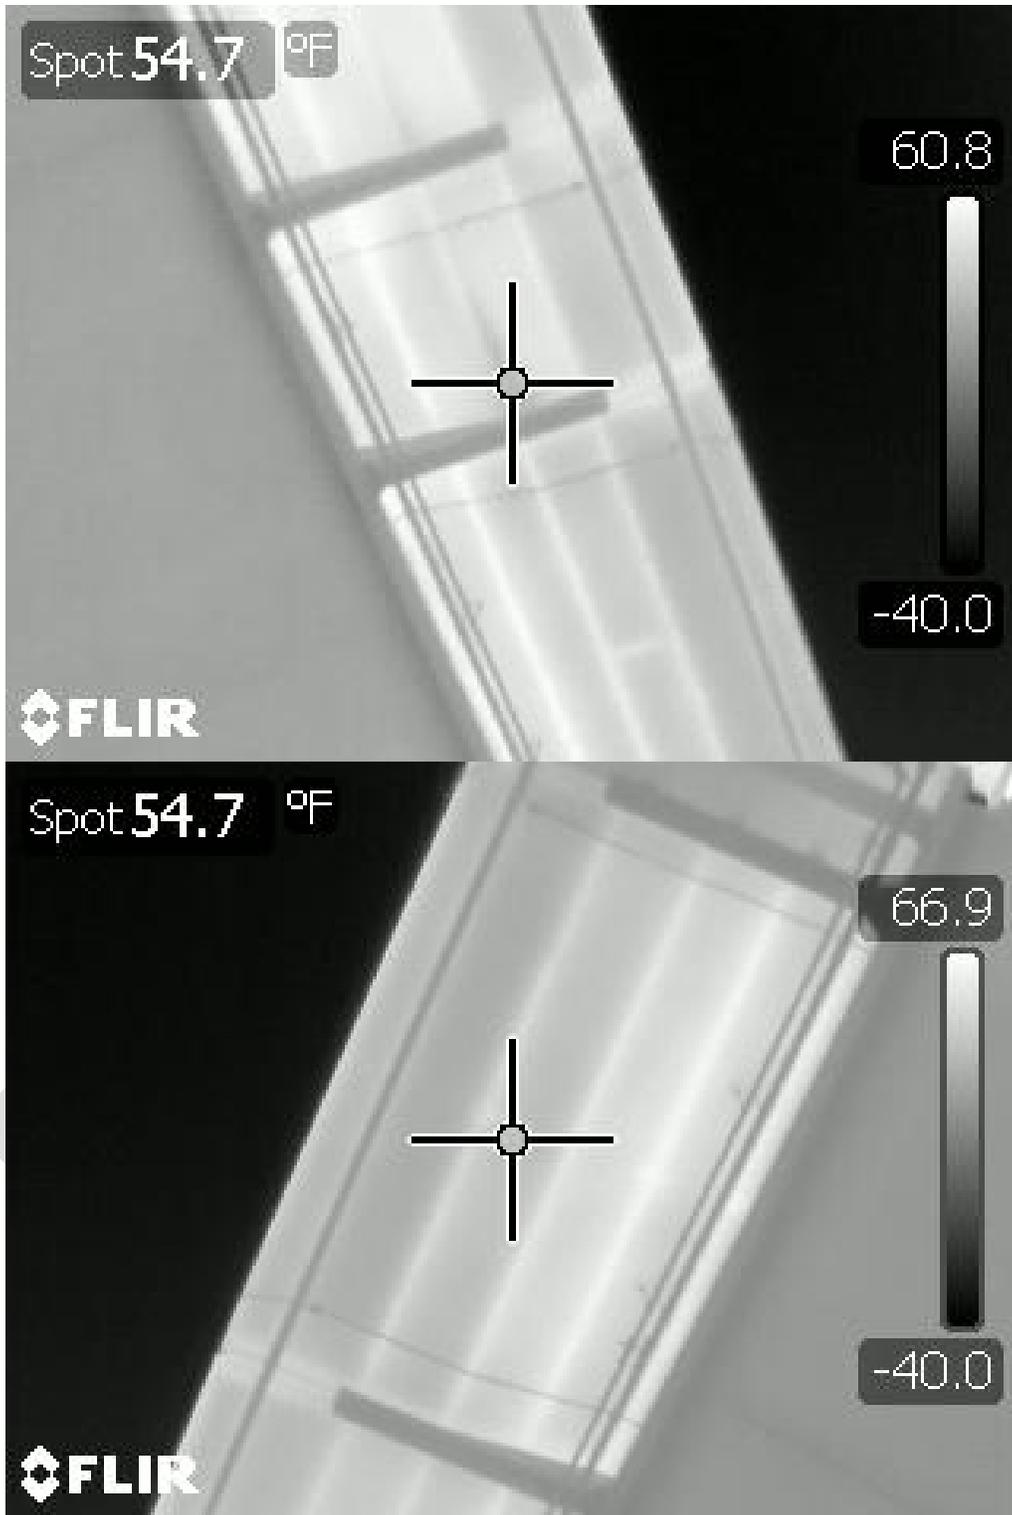
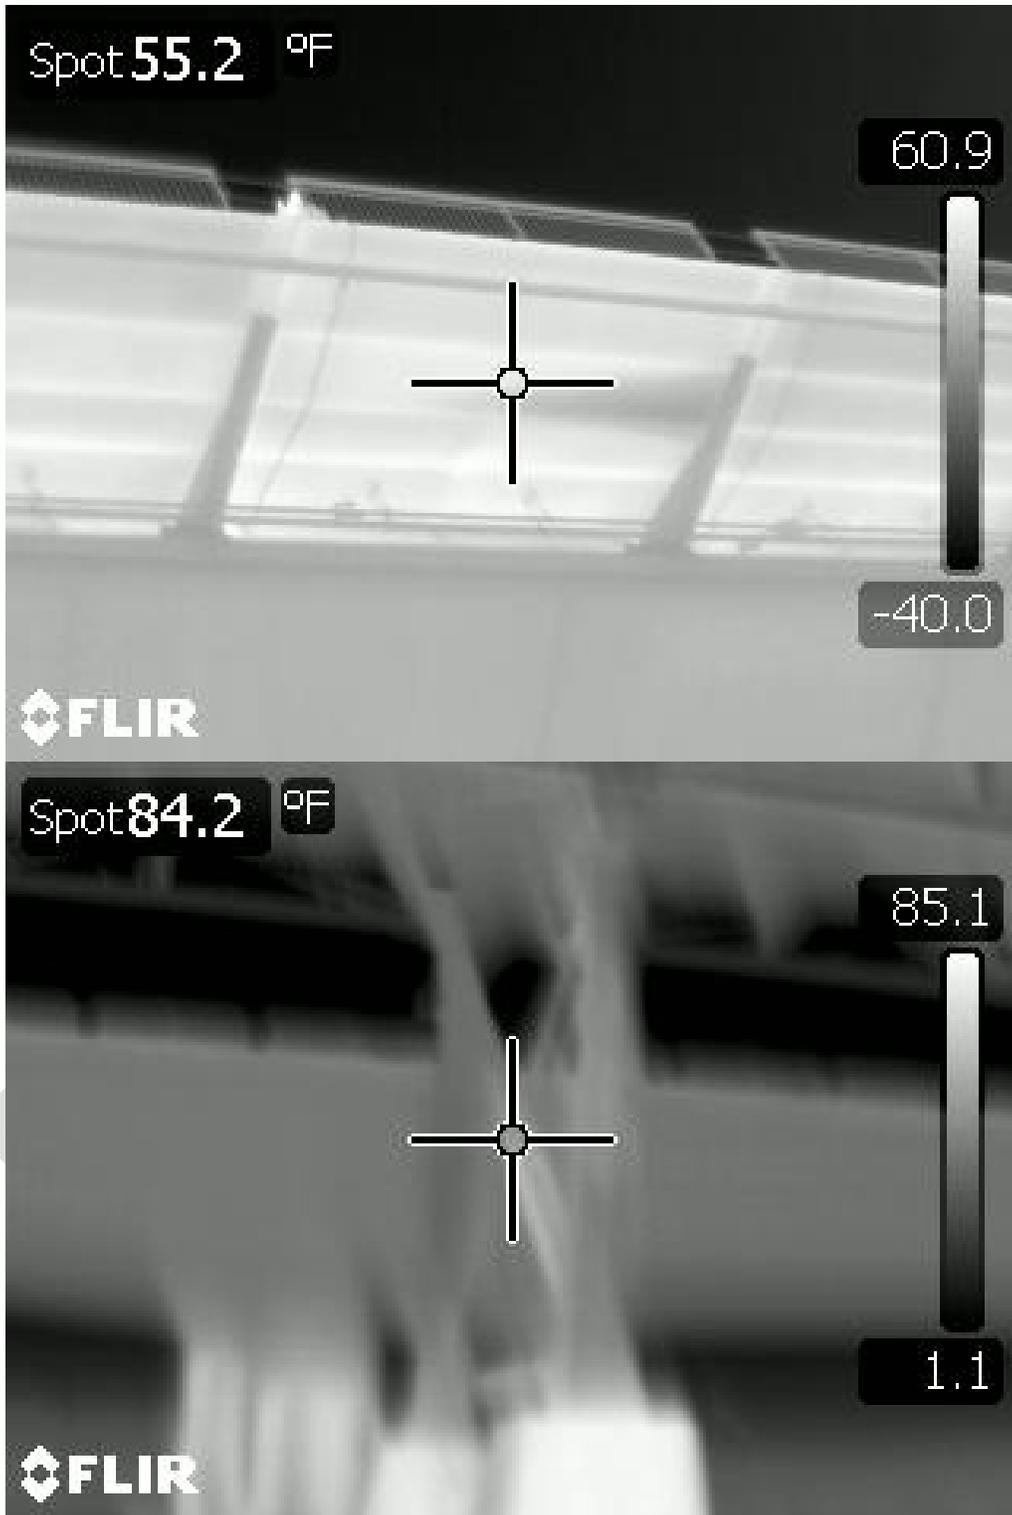
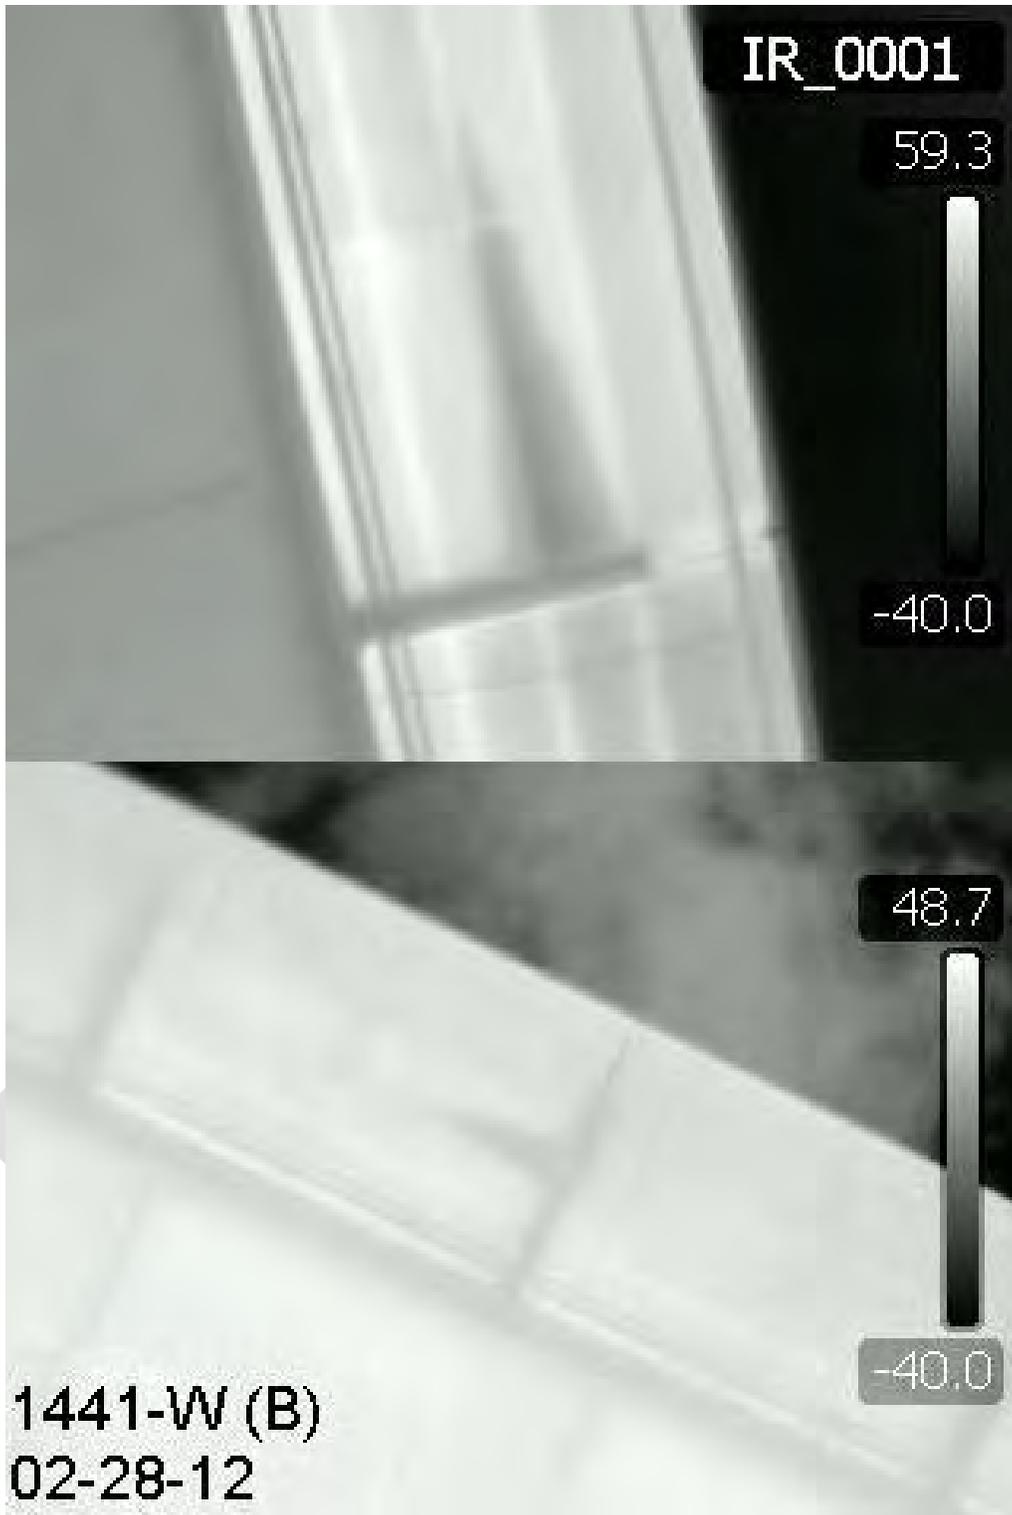
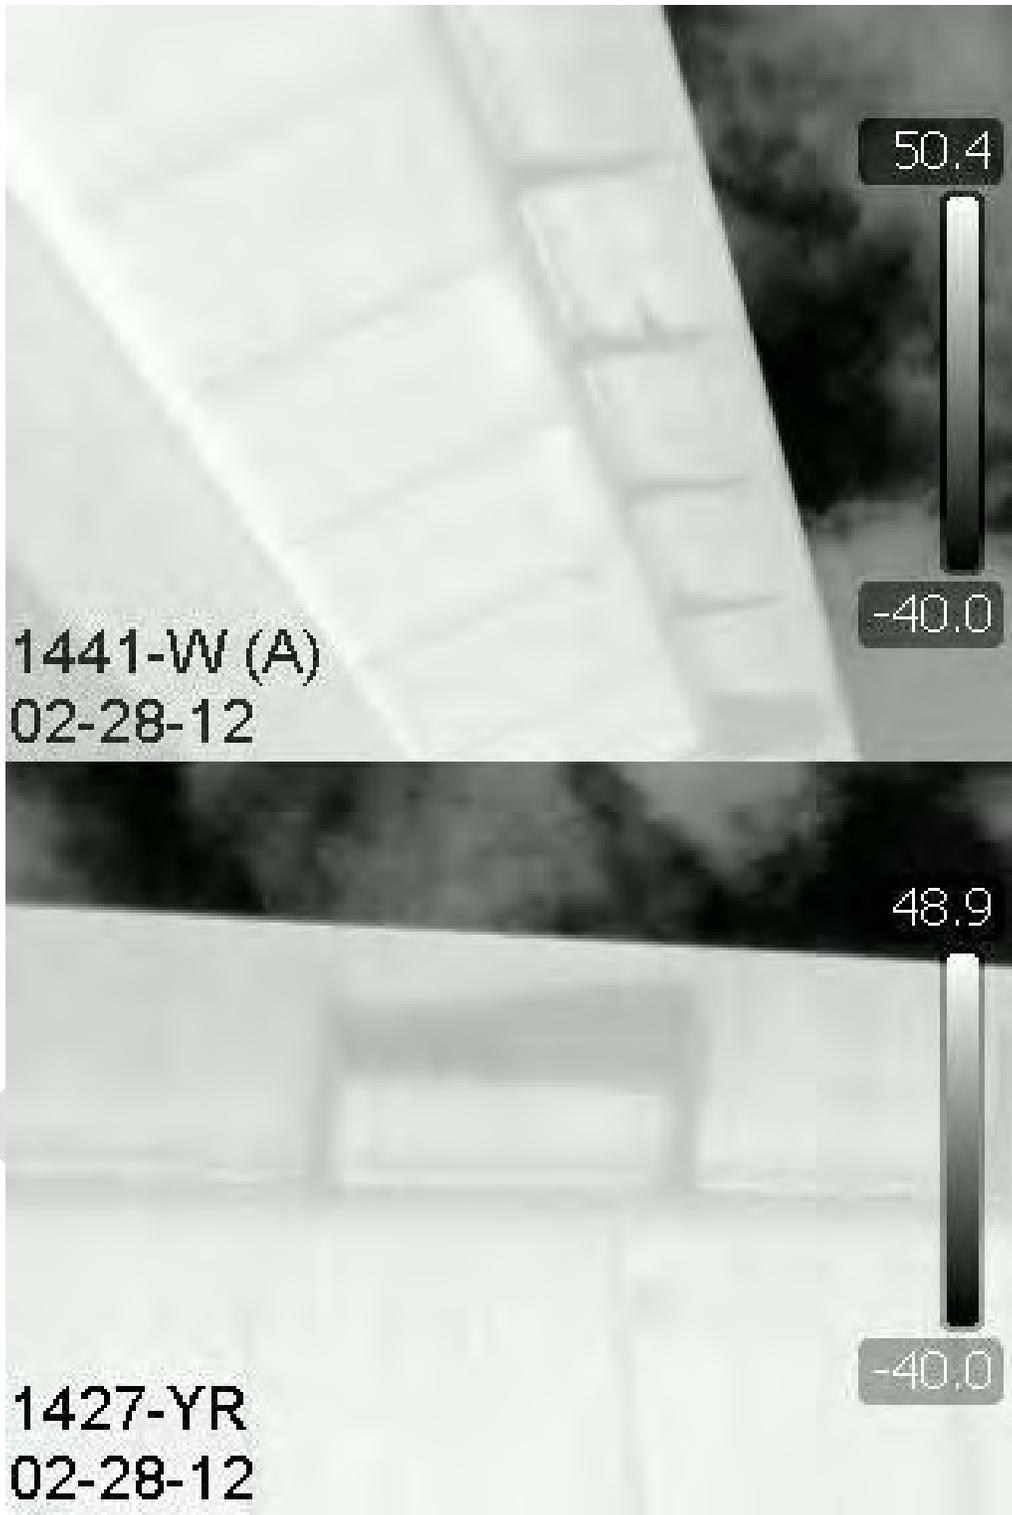
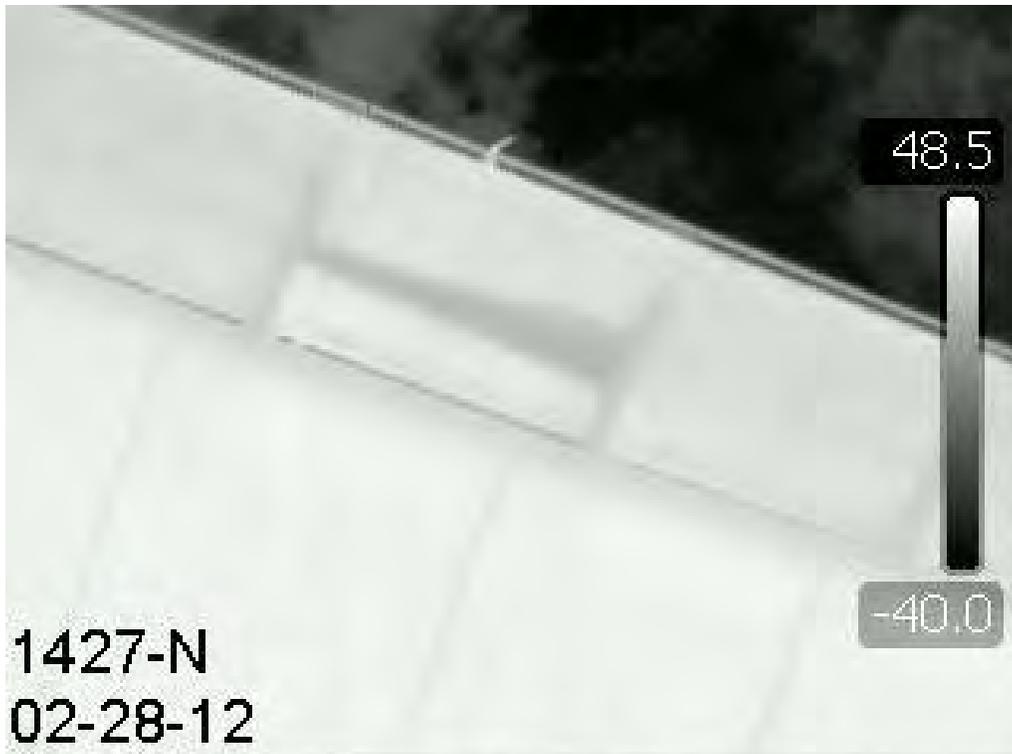
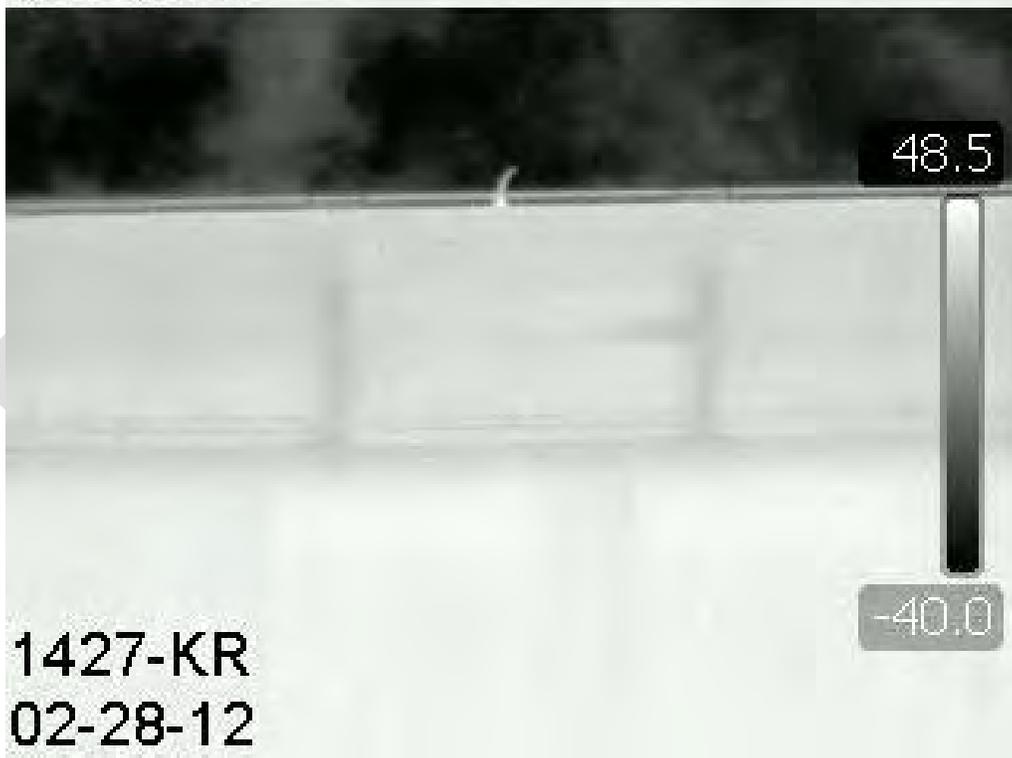
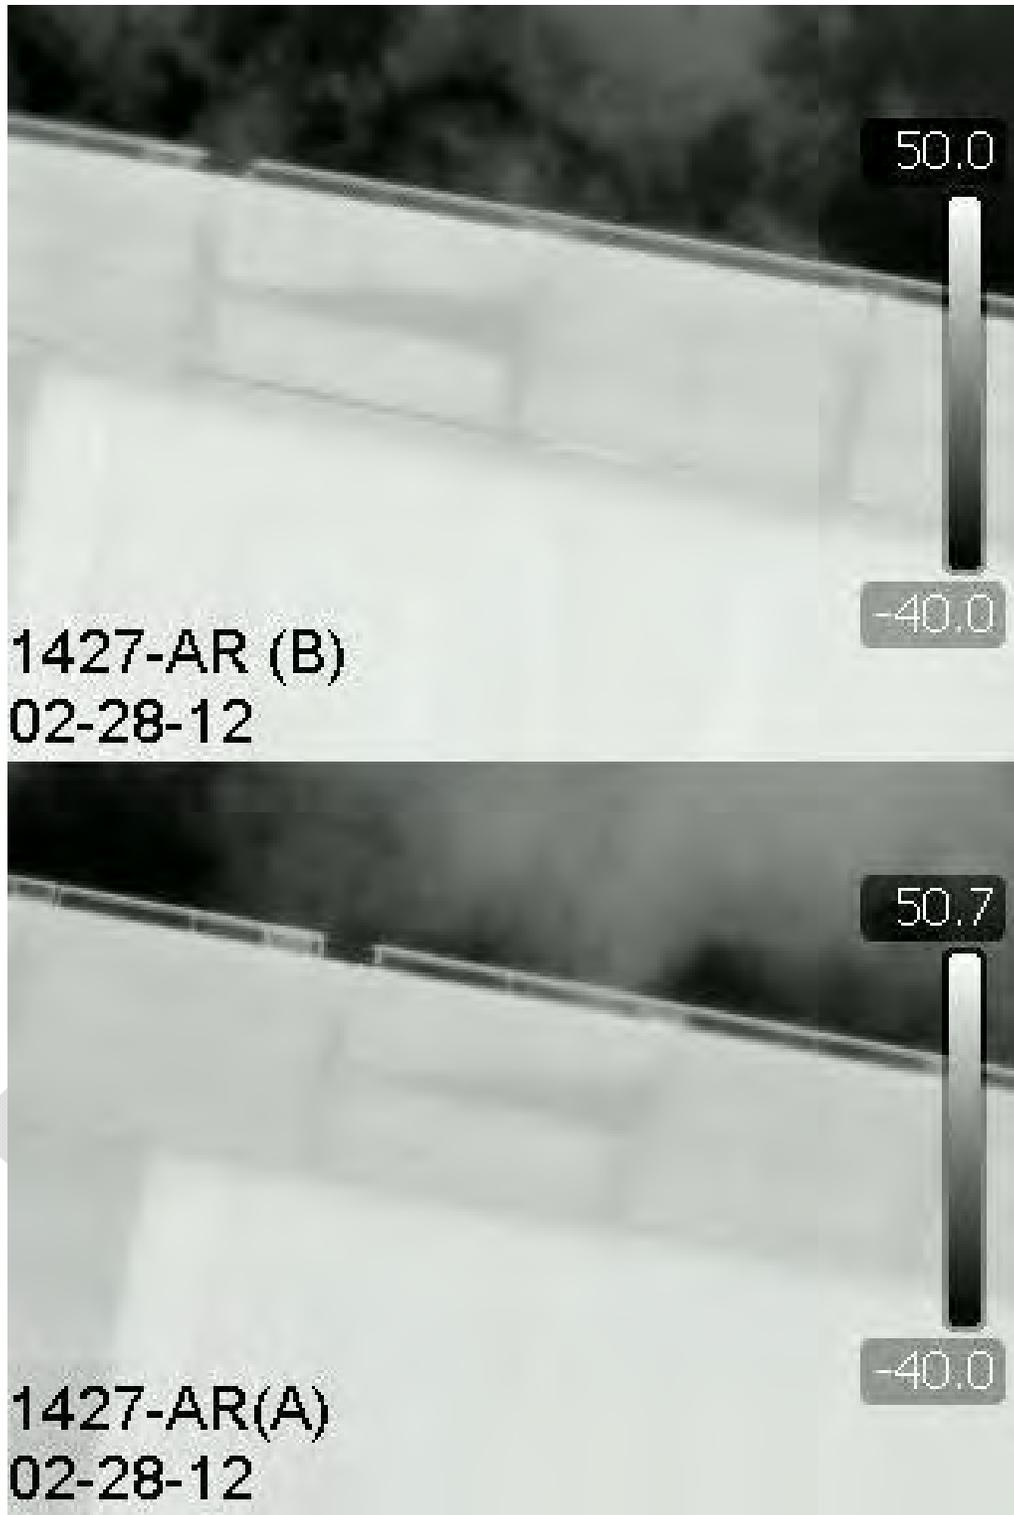
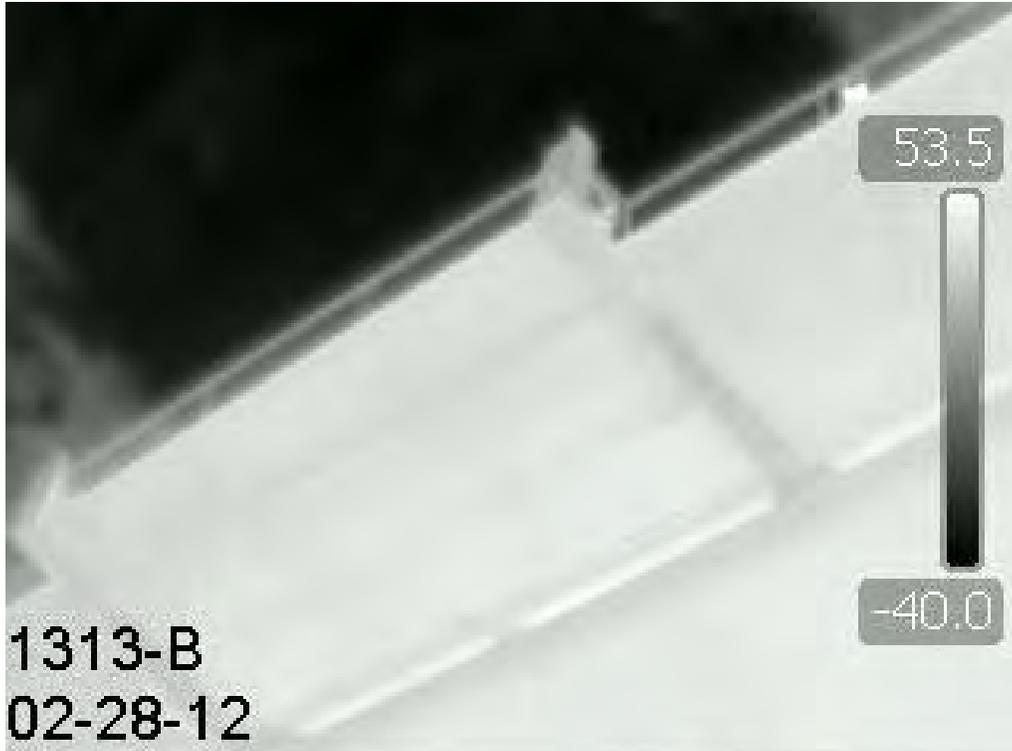
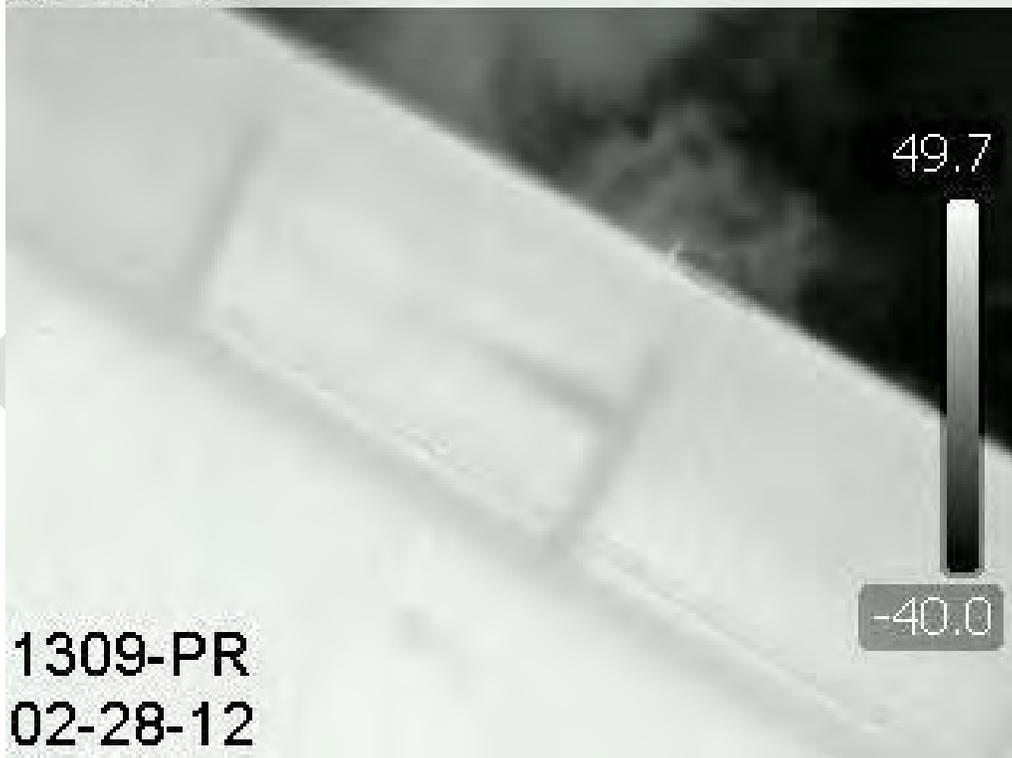
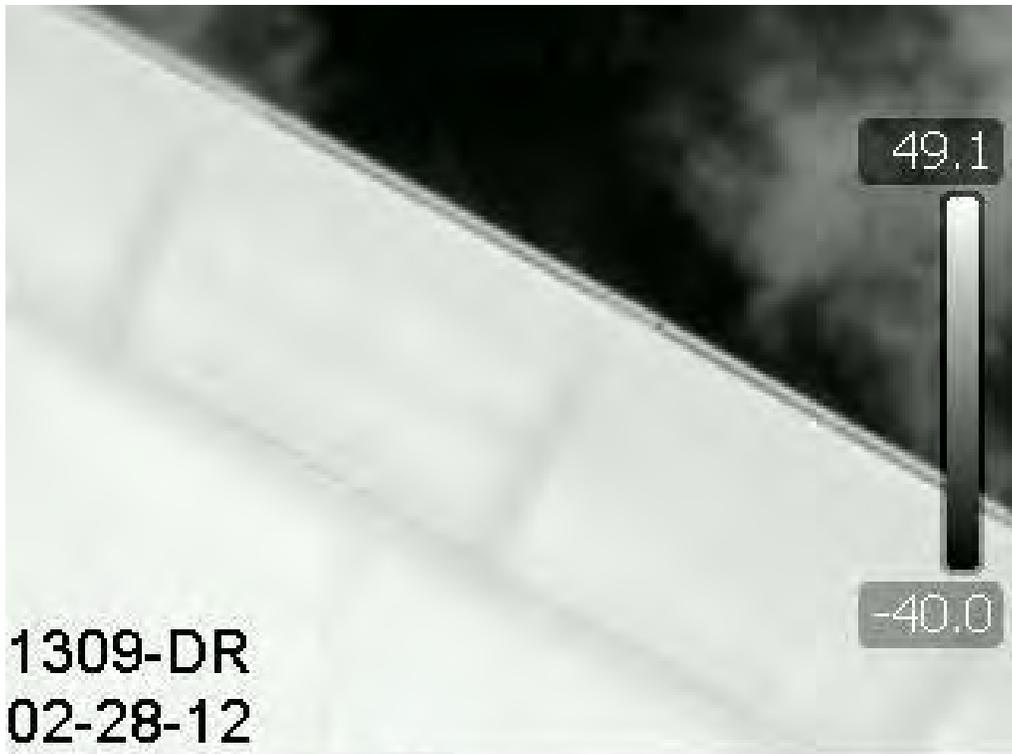
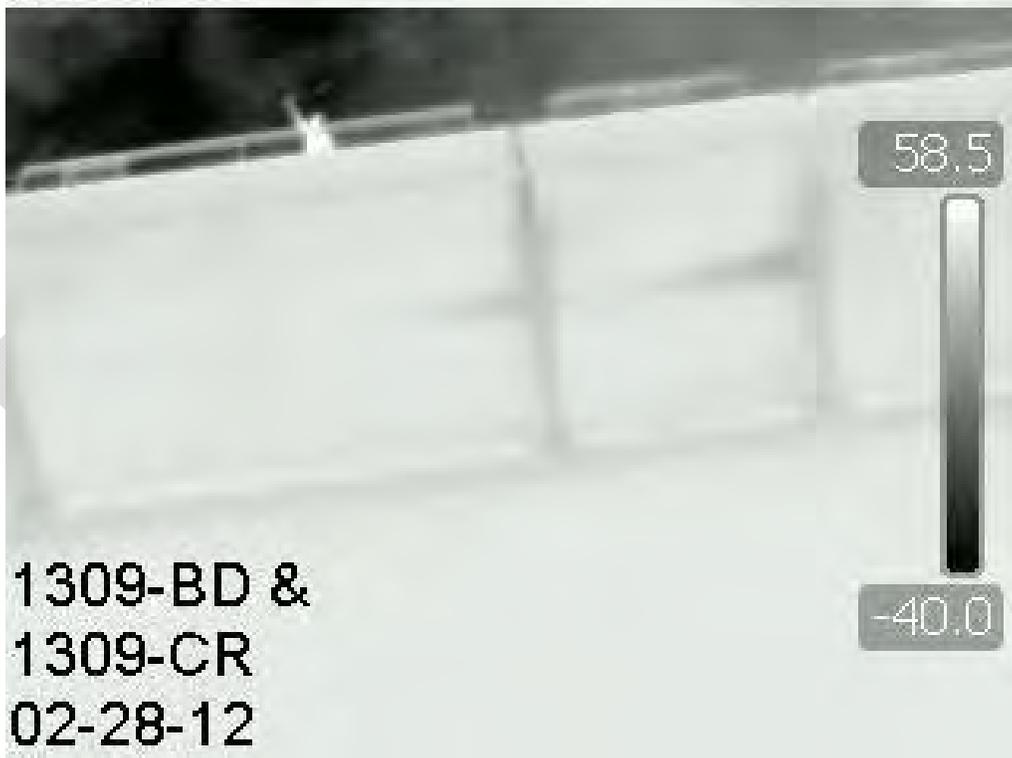
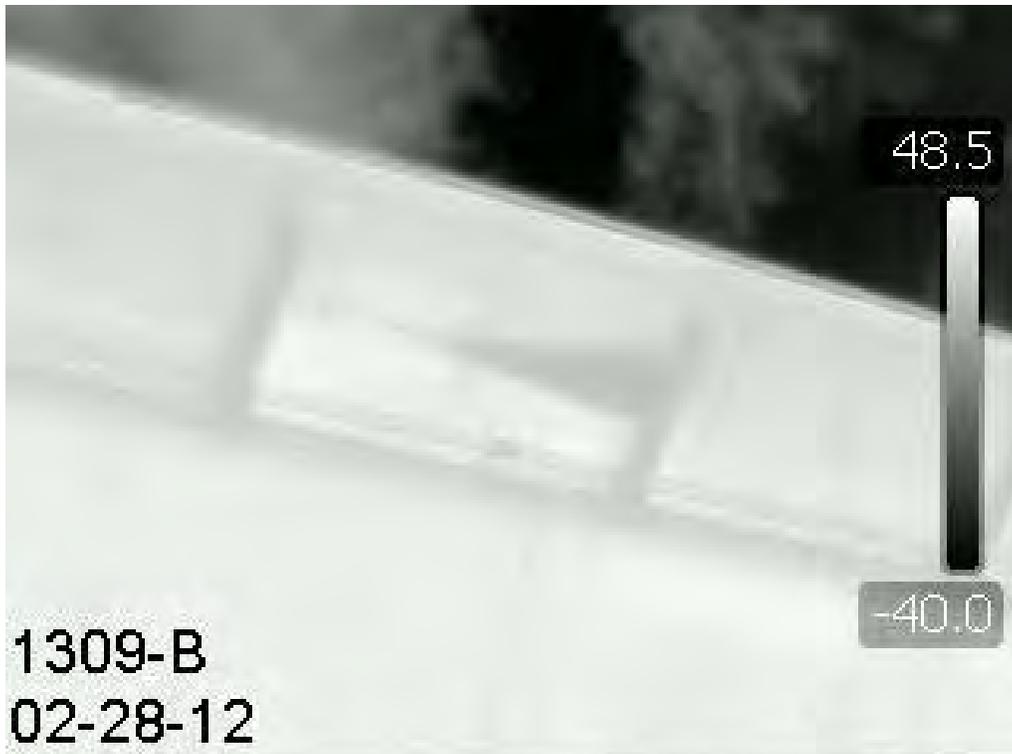
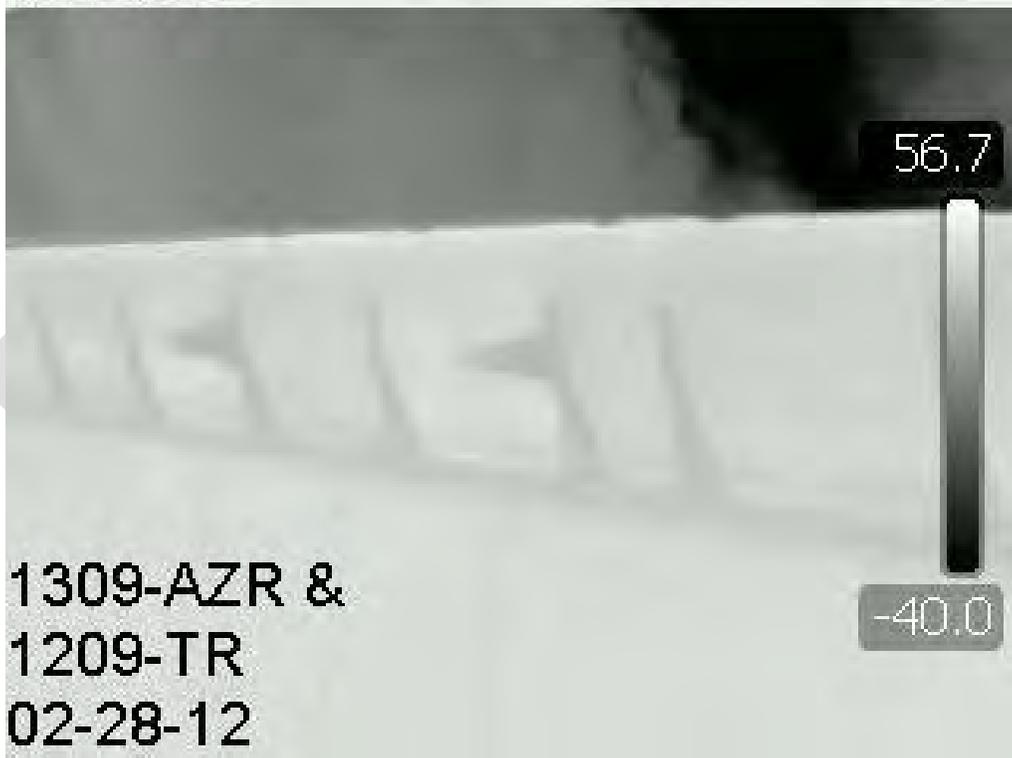
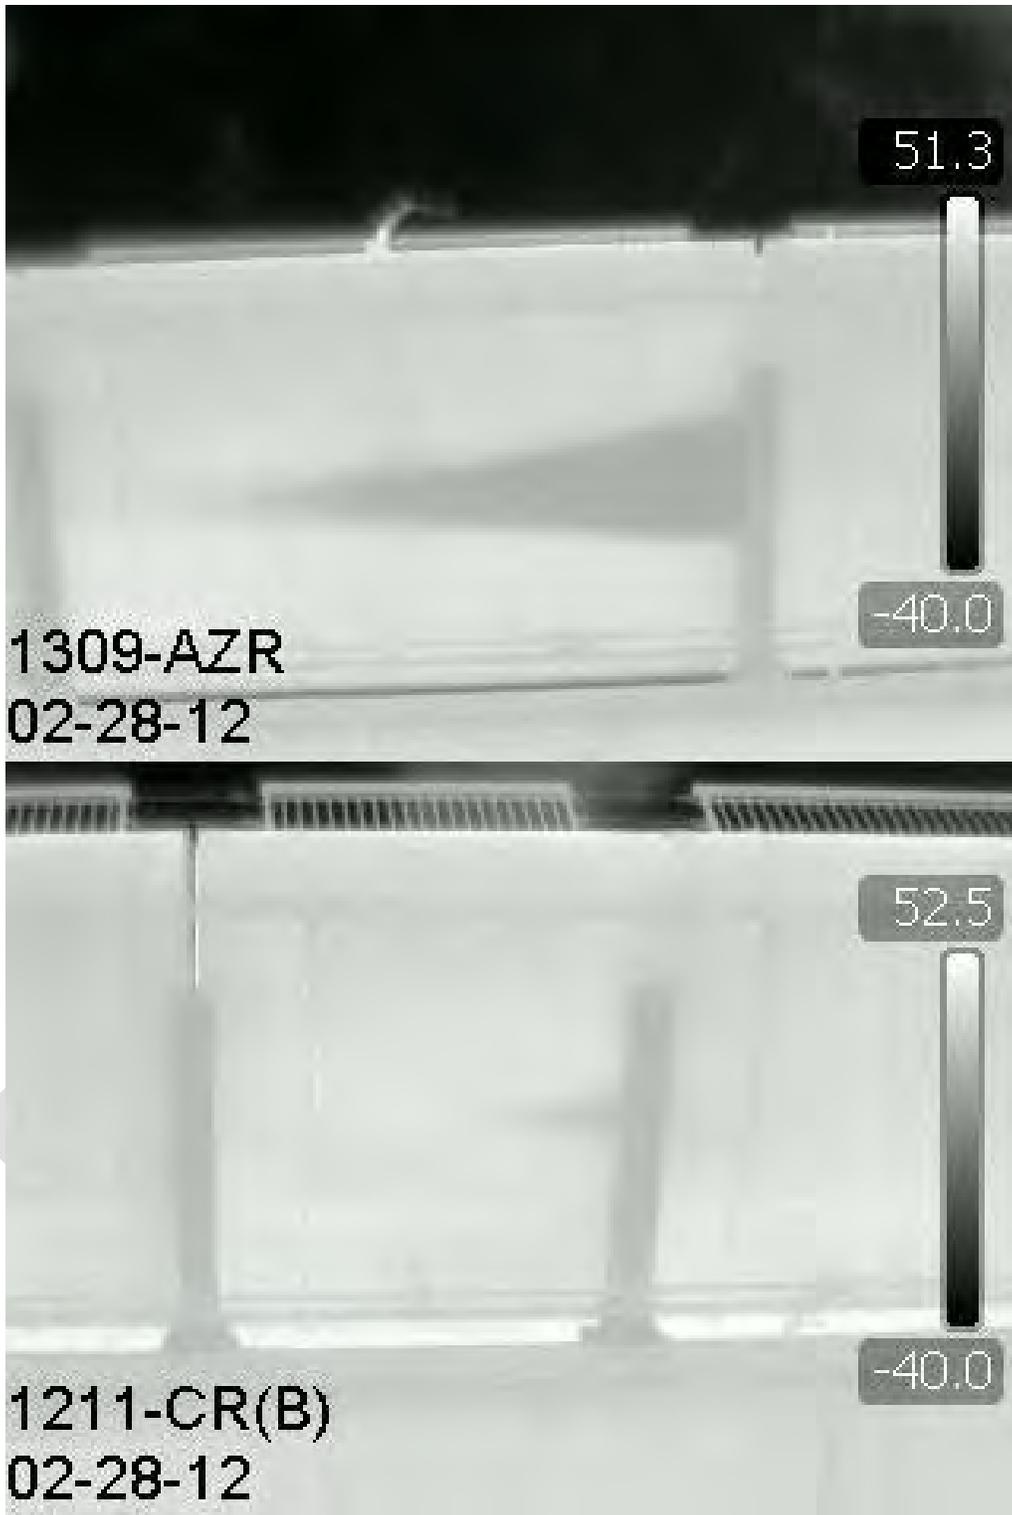
APPENDIX 1

During the demonstration, the FLIR camera revealed that several panels appeared to have standing water on the Skyway portion of the bridge (**Appendix 1**). The shape and location of the low temperature areas in a typical image (**Figure 1**) proved to be an effective method to identify the problematic panels. No panels showed signs of standing water on the SAS bike path.

Phase 1 & 2 FLIR T300 photos of bikepath panels identified with water intrusion. Performed by CT METS on 02-29-2012.

- 1.) Conduct biennial infrared camera surveys to detect any significant water ingress to box girders
- 2.) Dewater box girders known to hold water biennially and record extracted water volume. In addition, install valves at the lowest point of at least six box girders which are not known to contain water and include them as part of the dewatering program.
- 3.) Conduct a visual survey to evaluate the presence of damage or wear to the coating/overlay around the circular threaded caps in five years and biennially thereafter. If distress is observed, it should be addressed as soon as possible to minimize the ingress of water through the circular threaded caps.

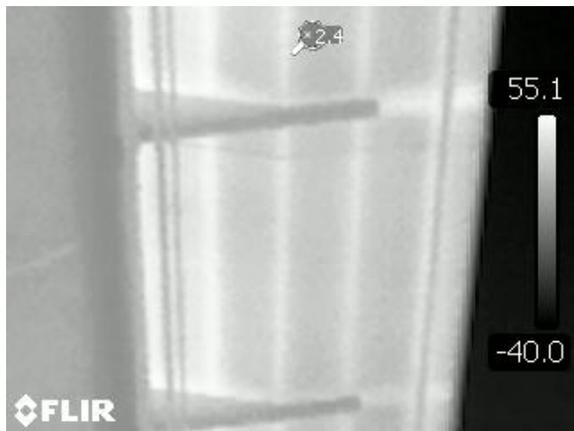
On 1/15/13, METS personnel conducted an infrared camera investigation, using a FLIR T300 camera. The infrared camera was aimed the bike path while the boat was driven from the end of the Skyway transition structure of the SAS to the beginning of the bike path in Oakland. Water intrusion could not be detected throughout the length of the bridge with the only exceptions being in the expansion joint panels. Water was also witnessed in the final two panels nearest the SAS structure where it is known to exist.

Figure 1. Typical Bikepath view on 1-15-13

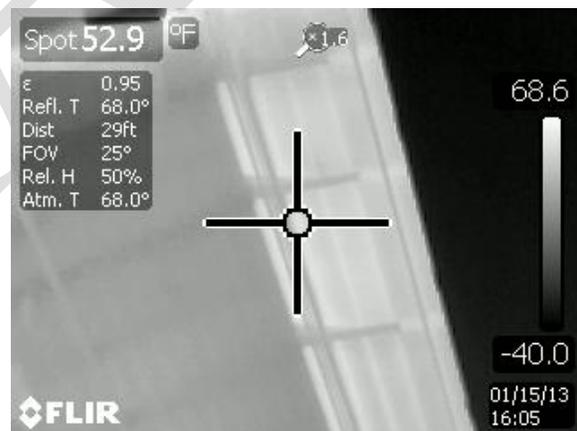
Figure 2. Typical Bikepath view on 1-15-13
